# Update on Salt Lake City and County Building Base Isolation

2021 SEAU EDUCATION CONFERENCE

***Jerod G. Johnson, PhD, SE***  
***Reaveley Engineers + Associates***

# Salt Lake City and County Building

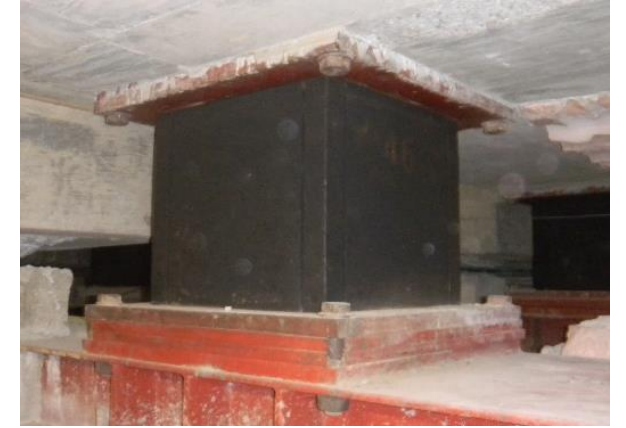
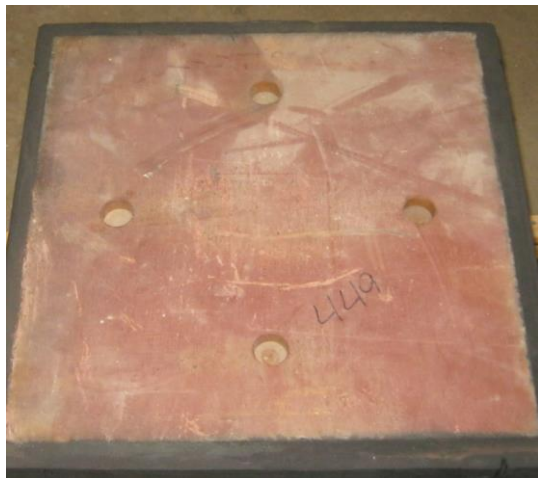
- Base Isolation Selected
- 443 Rectilinear Isolators (239 w/ lead, 204 w/o lead)
- 1985 UBC prescribed 0.1g lateral acceleration for ductile structures
- Renovation design used 0.2g
- Scaled versions of 1979 Imperial Valley Earthquake
  - Arrays #7, #8 and Bond Corner Accelerograms
- Isolators measuring 17" x 17" x 15"
- System Displacement of 4 inches

Note: top and bottom mounting plates developed for shear transfer only.

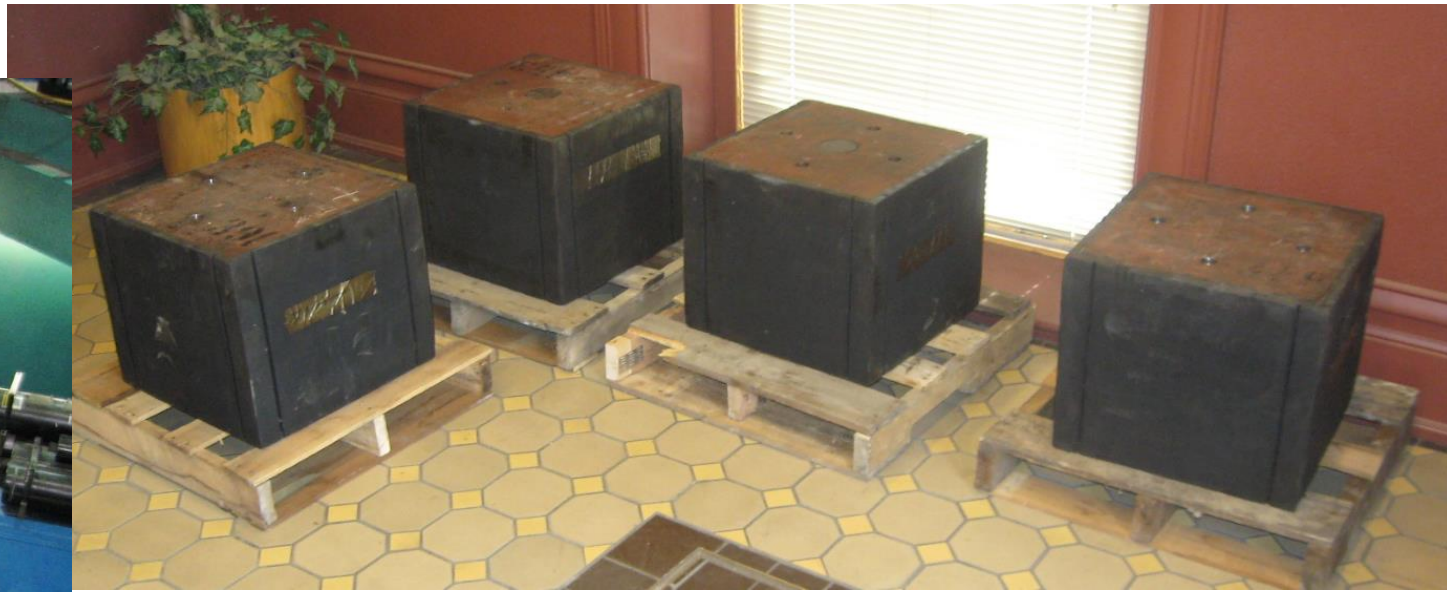
# Testing Update – Modern Protocol

- CALTRANS – UCSD Powell Lab
- Full axial load ( $\sim 350\text{k}$ )
- Rate of load ( $\sim 2.5$  sec/cycle)
- Test to failure
